BAKER (MICHAEL) JR INC BEAVER PA
NATIONAL DAM SAFETY PROGRAM, BUFFALO RIVER NUMBER 2 JAMES RIVER--ETC(U)
SEP 79

NAME OF DAM: BUFFALO RIVER No. 2

PHASE I INSPECTION REPORT
NATIONAL DAM SAFETY PROGRAM
NAME OF DAM: BUFFALO RIVER No. 2 ID #VA 00912

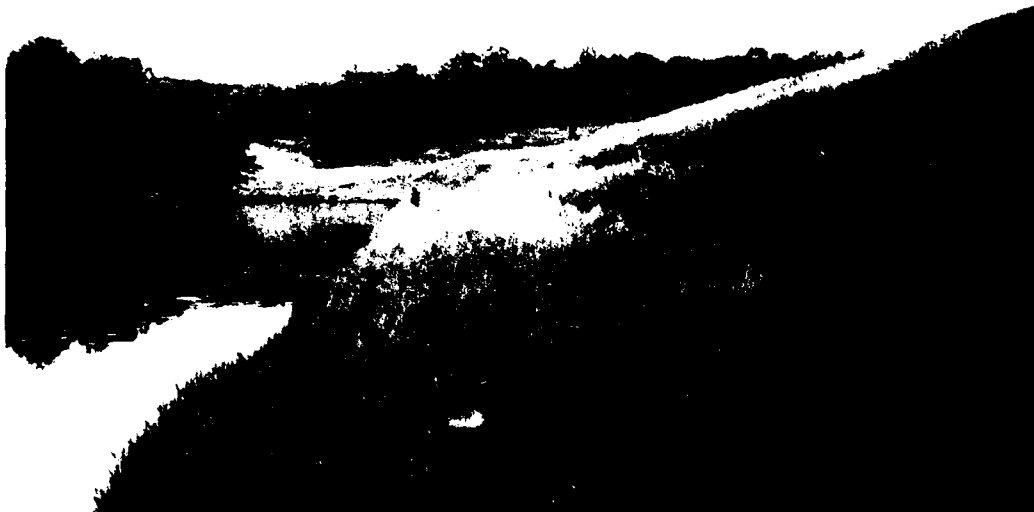
PHOTO 1. Upstream Face of Dam Looking Toward Approach to Emergency Spillway

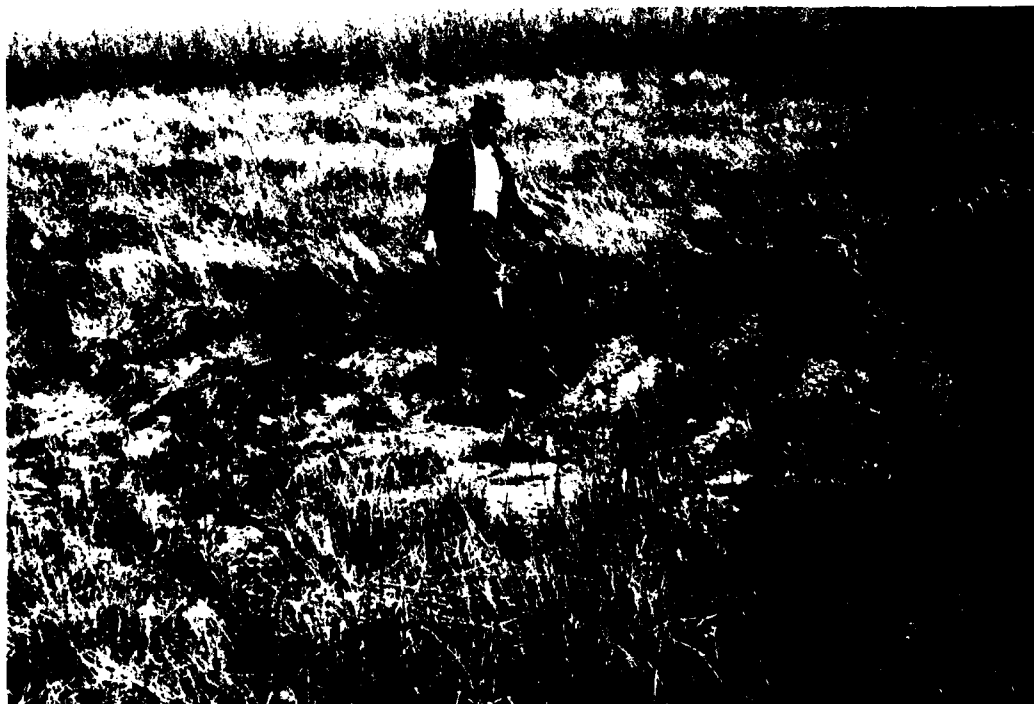
- 6.2.1 Visual Observations: No evidence of movement, such as tension cracks or bulging of the embankment, was noted. There was some erosion and slight sloughing located 50 feet from the left abutment in the soft wet clayey silt (100 foot by 20 foot area) just above the toe of the upstream slope. Several tree branches are imbedded in the soil. There are minor erosion gullies on the downstream slope. Otherwise, the embankment is in good condition with no visible seepage on the downstream slope.

PHOTO 2. Sloughing and Erosion Area Near Upstream Left Abutment

- 1) Remove wet sloughing soil with imbedded branches near the left upstream abutment and replace with compacted earth.
- 2) Grade and seed eroded bare areas near the bench on the downstream slope. Also, grade and seed erosion gullies in the vicinity of the rock gutters at the left downstream abutment and right upstream abutment.
- 3) Seed and fertilize areas with dead grass.
- 4) Remove driftwood on shoreline of dam and fallen branches from rock gutters.
- 5) Place additional stone riprap on the banks of the stilling basin where discharge has washed it away.
- 6) Remove small tree from stone riprap adjacent to left wing wall of impact basin.
- 7) Fill and seed erosion gullies in discharge channel of emergency spillway.
- 8) Install a staff gage to monitor reservoir levels above normal pool.

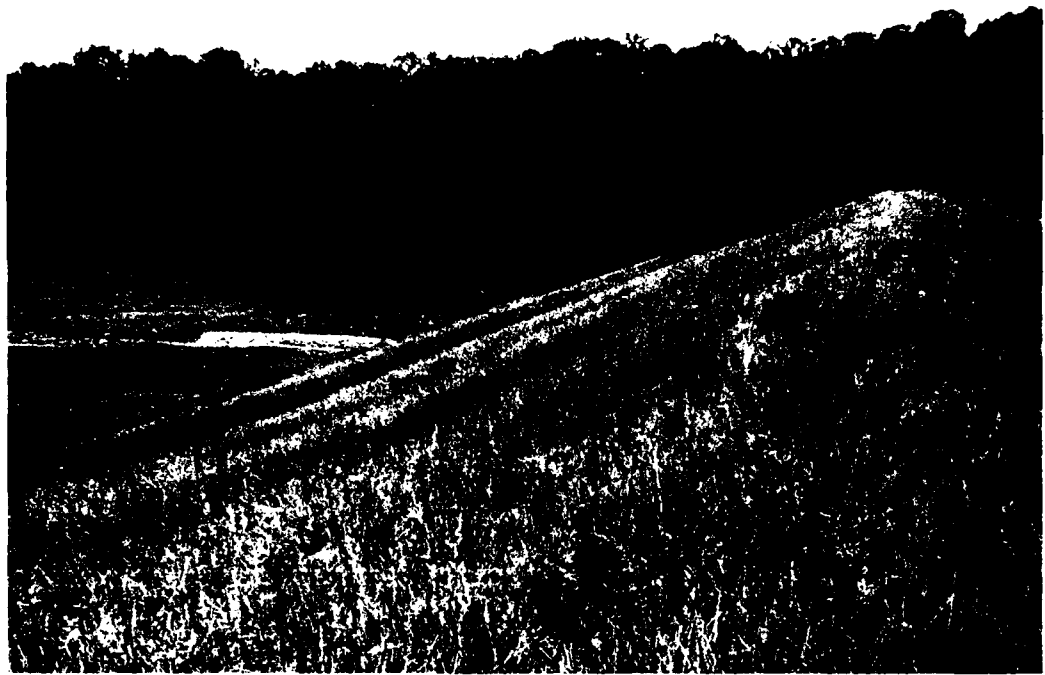
PHOTO 3. Downstream Face of Dam

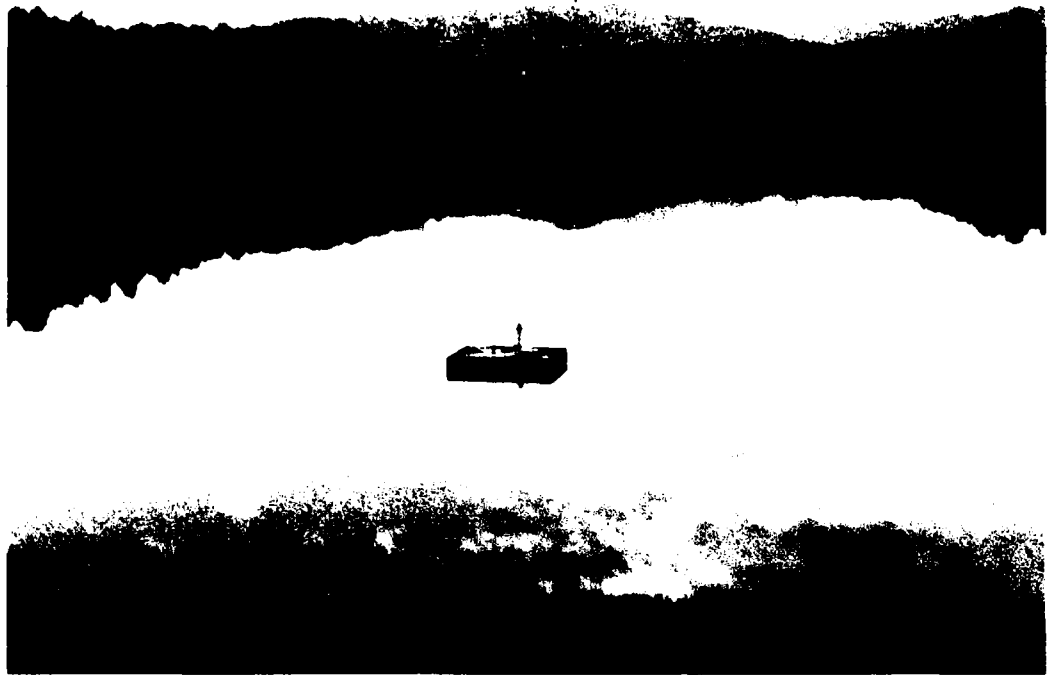
PHOTO 5. View of Riser and Reservoir from Crest of Dam

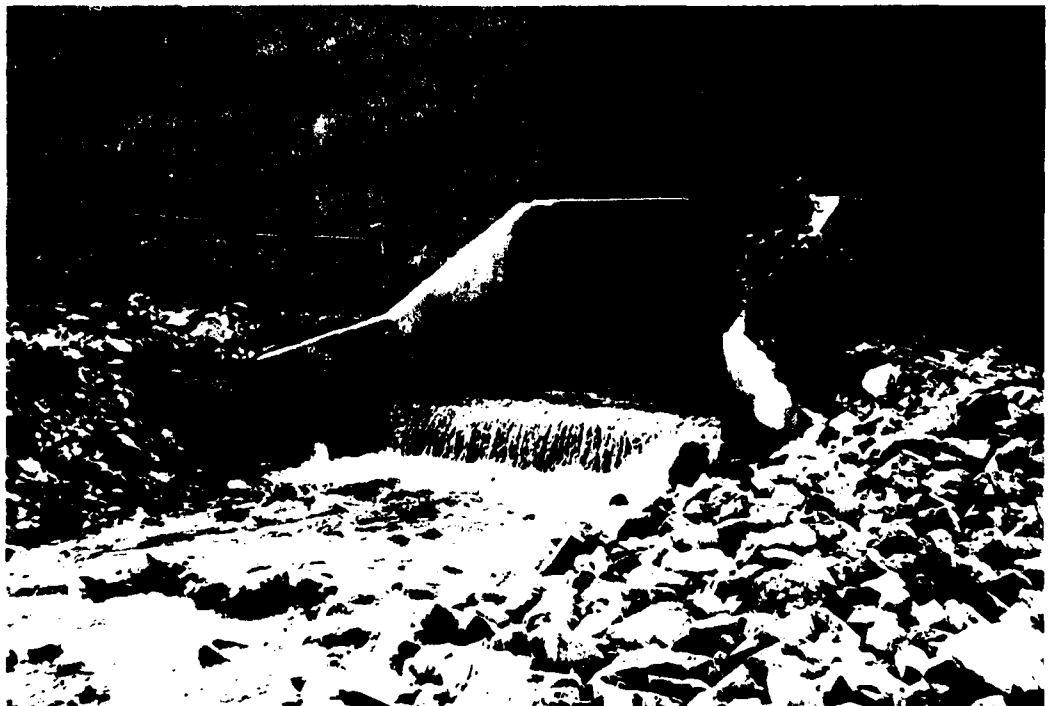
- 3.1.3 Appurtenant Structures: The principal spillway was functioning satisfactorily (see Photo 6) and no structural deficiencies were found on the appurtenant structures.

PHOTO 6. Outlet of Principal Spillway, Impact Basin and Riprap-Lined Channel

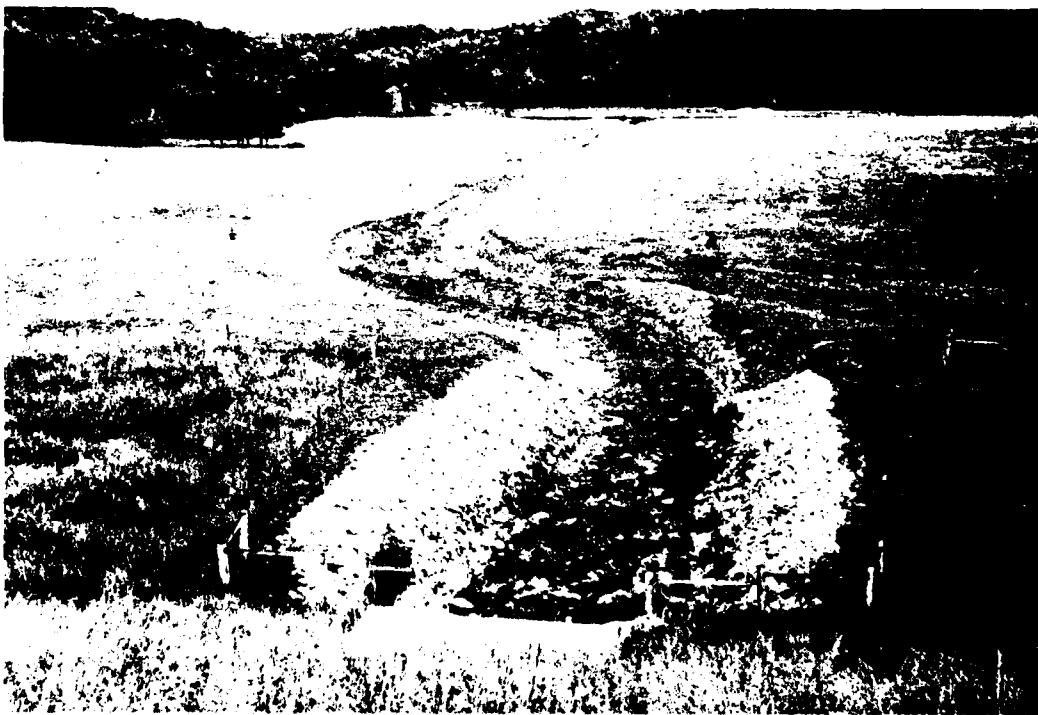
PHOTO 8. Downstream Area with VA Route 610 and Farmhouse in Background
